Clovelly Dykes hillfort – ramparts 1 & 2

A large Iron Age hillfort with views across the coast, and possible later re-use. Ramparts (banks and ditches forming enclosed spaces) are numbered 1-5 from the middle outward

Clovelly Dykes hillfort – ramparts 3, 4 & 5

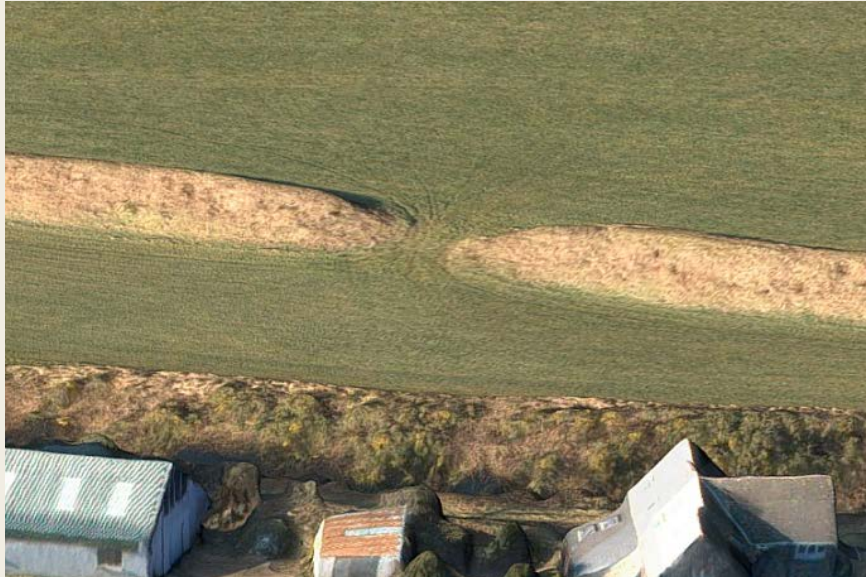
Eastern entrance on rampart 1

*T*his gap in rampart 1 is thought to have been made in the prehistoric period. There are also a small number of other gaps in the rampart, although these are more likely to be medieval or later in date. Some are so narrow that they can only be the result of erosion from people and livestock moving across the site.

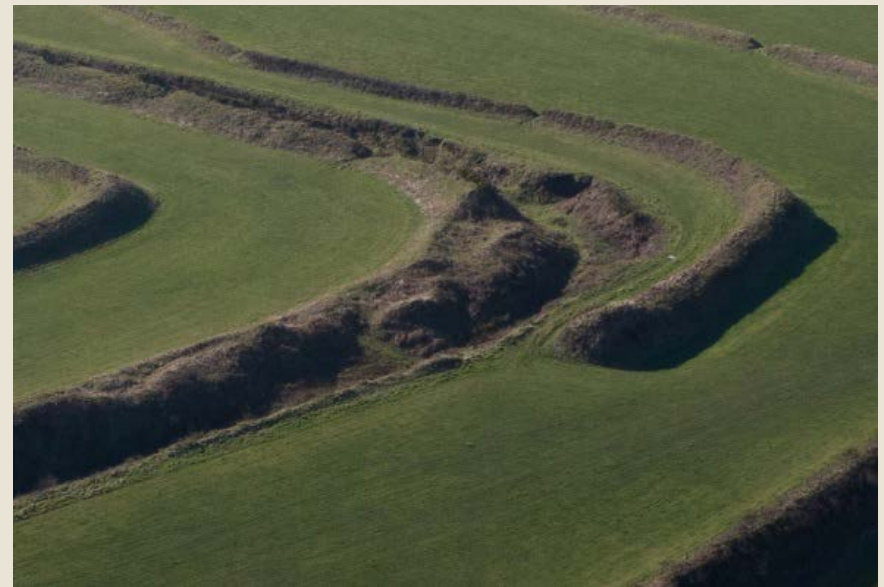
The largest visible banks

*T*he largest of the banks at Clovelly Dykes hillfort are on its north-western side, on rampart 2. It is most likely these banks which are visible from Windbury Hill to the west, where there is another coastal hillfort. These banks are probably also visible from the sea on a clear day.

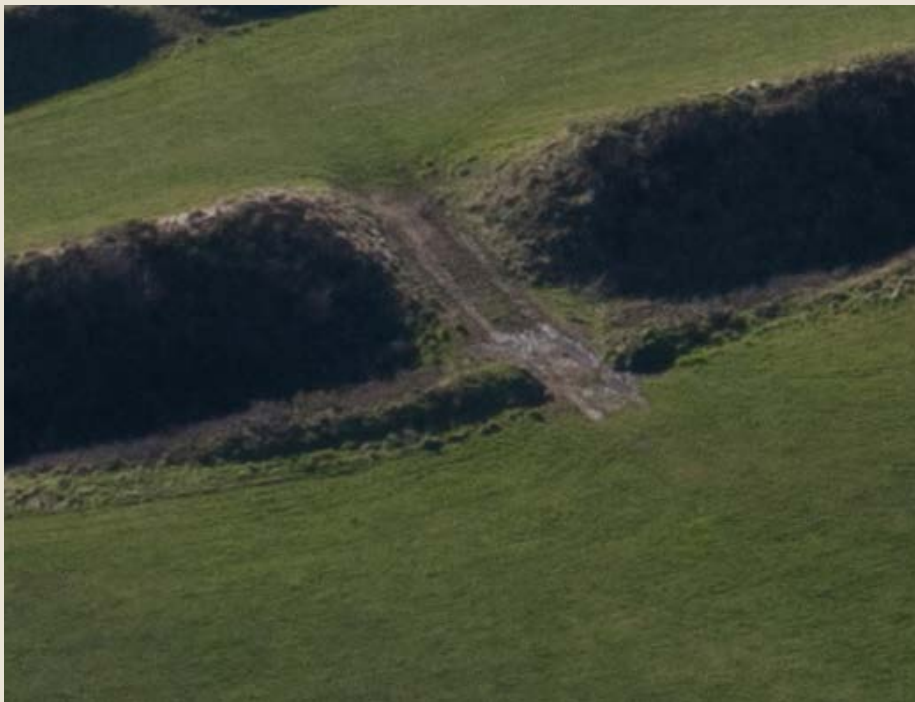
Northern entrance on rampart 2

This does not appear on historic maps, but it does show some typical characteristics of a prehistoric hillfort entrance. Perhaps a small entrance here was not historically mapped, and was later made larger to fit farming vehicles through it.

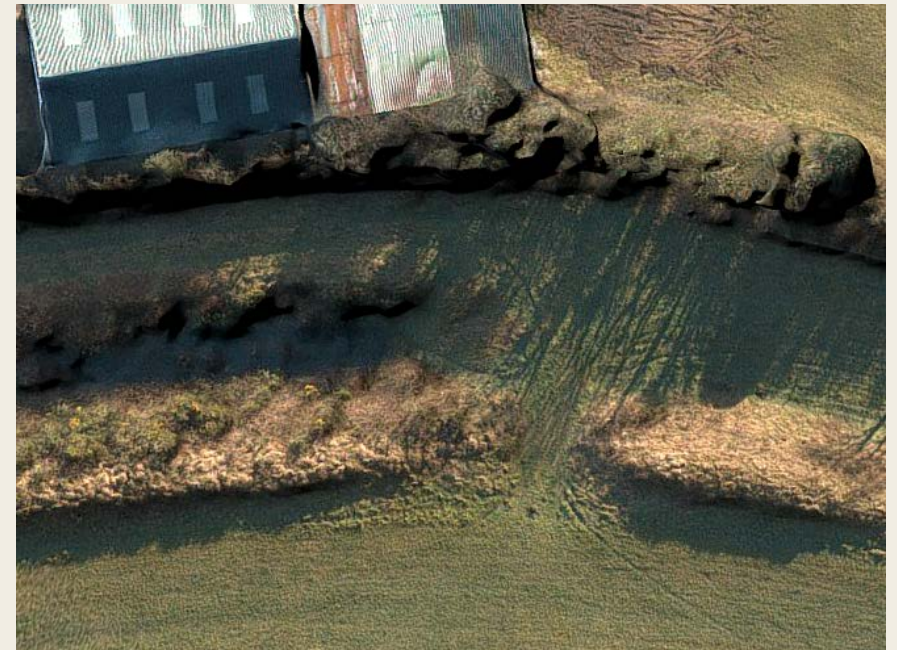
Eastern entrance on rampart 2, and the disappearing ditch

Like rampart 1, rampart 2 has an entrance on its eastern side. The interesting difference with this entrance is that the rampart ditch ends as would be expected on one side of it, but does not carry on after the entrance gap. What does this mean? Perhaps this shows that this part of the rampart was changed during the Roman period, or that something changed in the construction of this rampart in the prehistoric period.

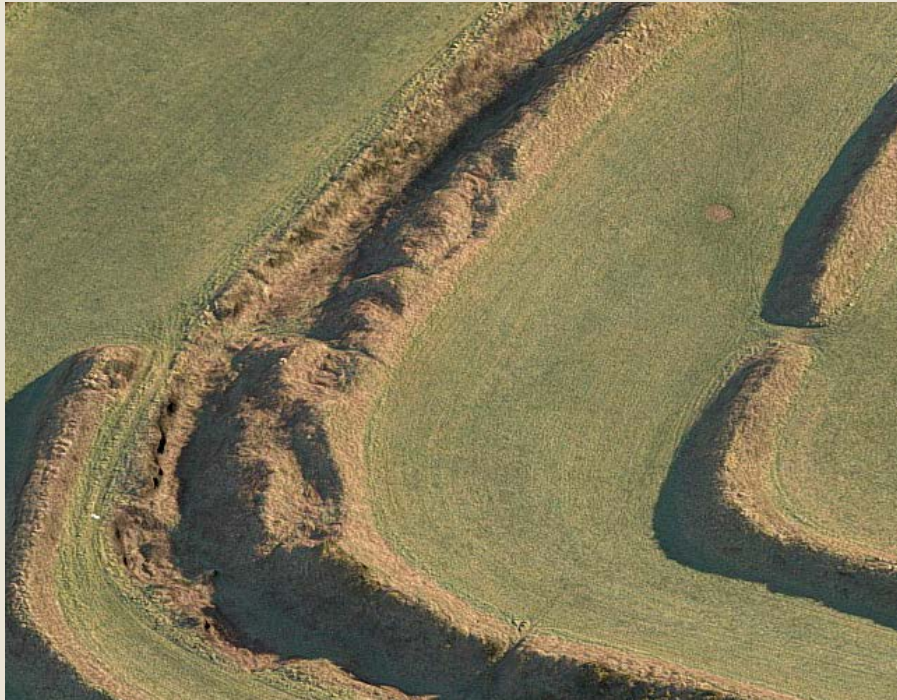
Later changes to rampart 2

There are some unusual differences in the bank and ditch in the north-west area of rampart 2. Here, there appears to have been some removal of earth from the bank, and the ditch seems to have been made wider. If the bank contained stone, it may have been taken to build nearby buildings. It is also possible that the earth was moved to help construct the nearby medieval field boundaries.

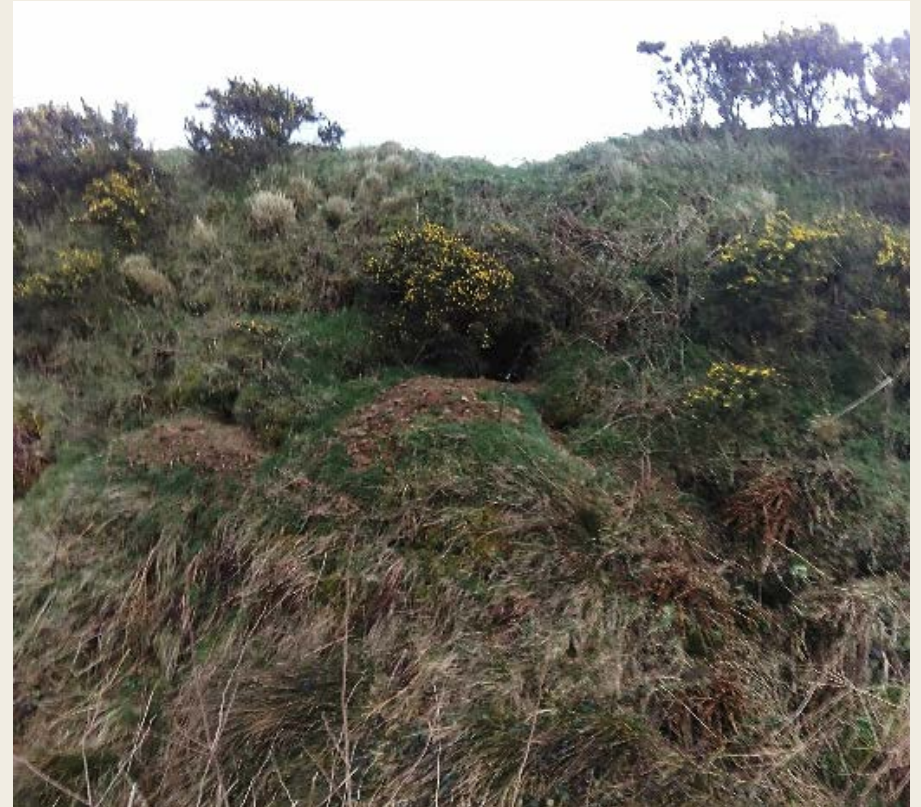
Badger sett

There are many things which can damage ancient monuments over time. Animals can be one, and at Clovelly Dykes hillfort, we can see a large badger sett on rampart 2. This is so large, that it is visible on the inside and outside of the rampart.

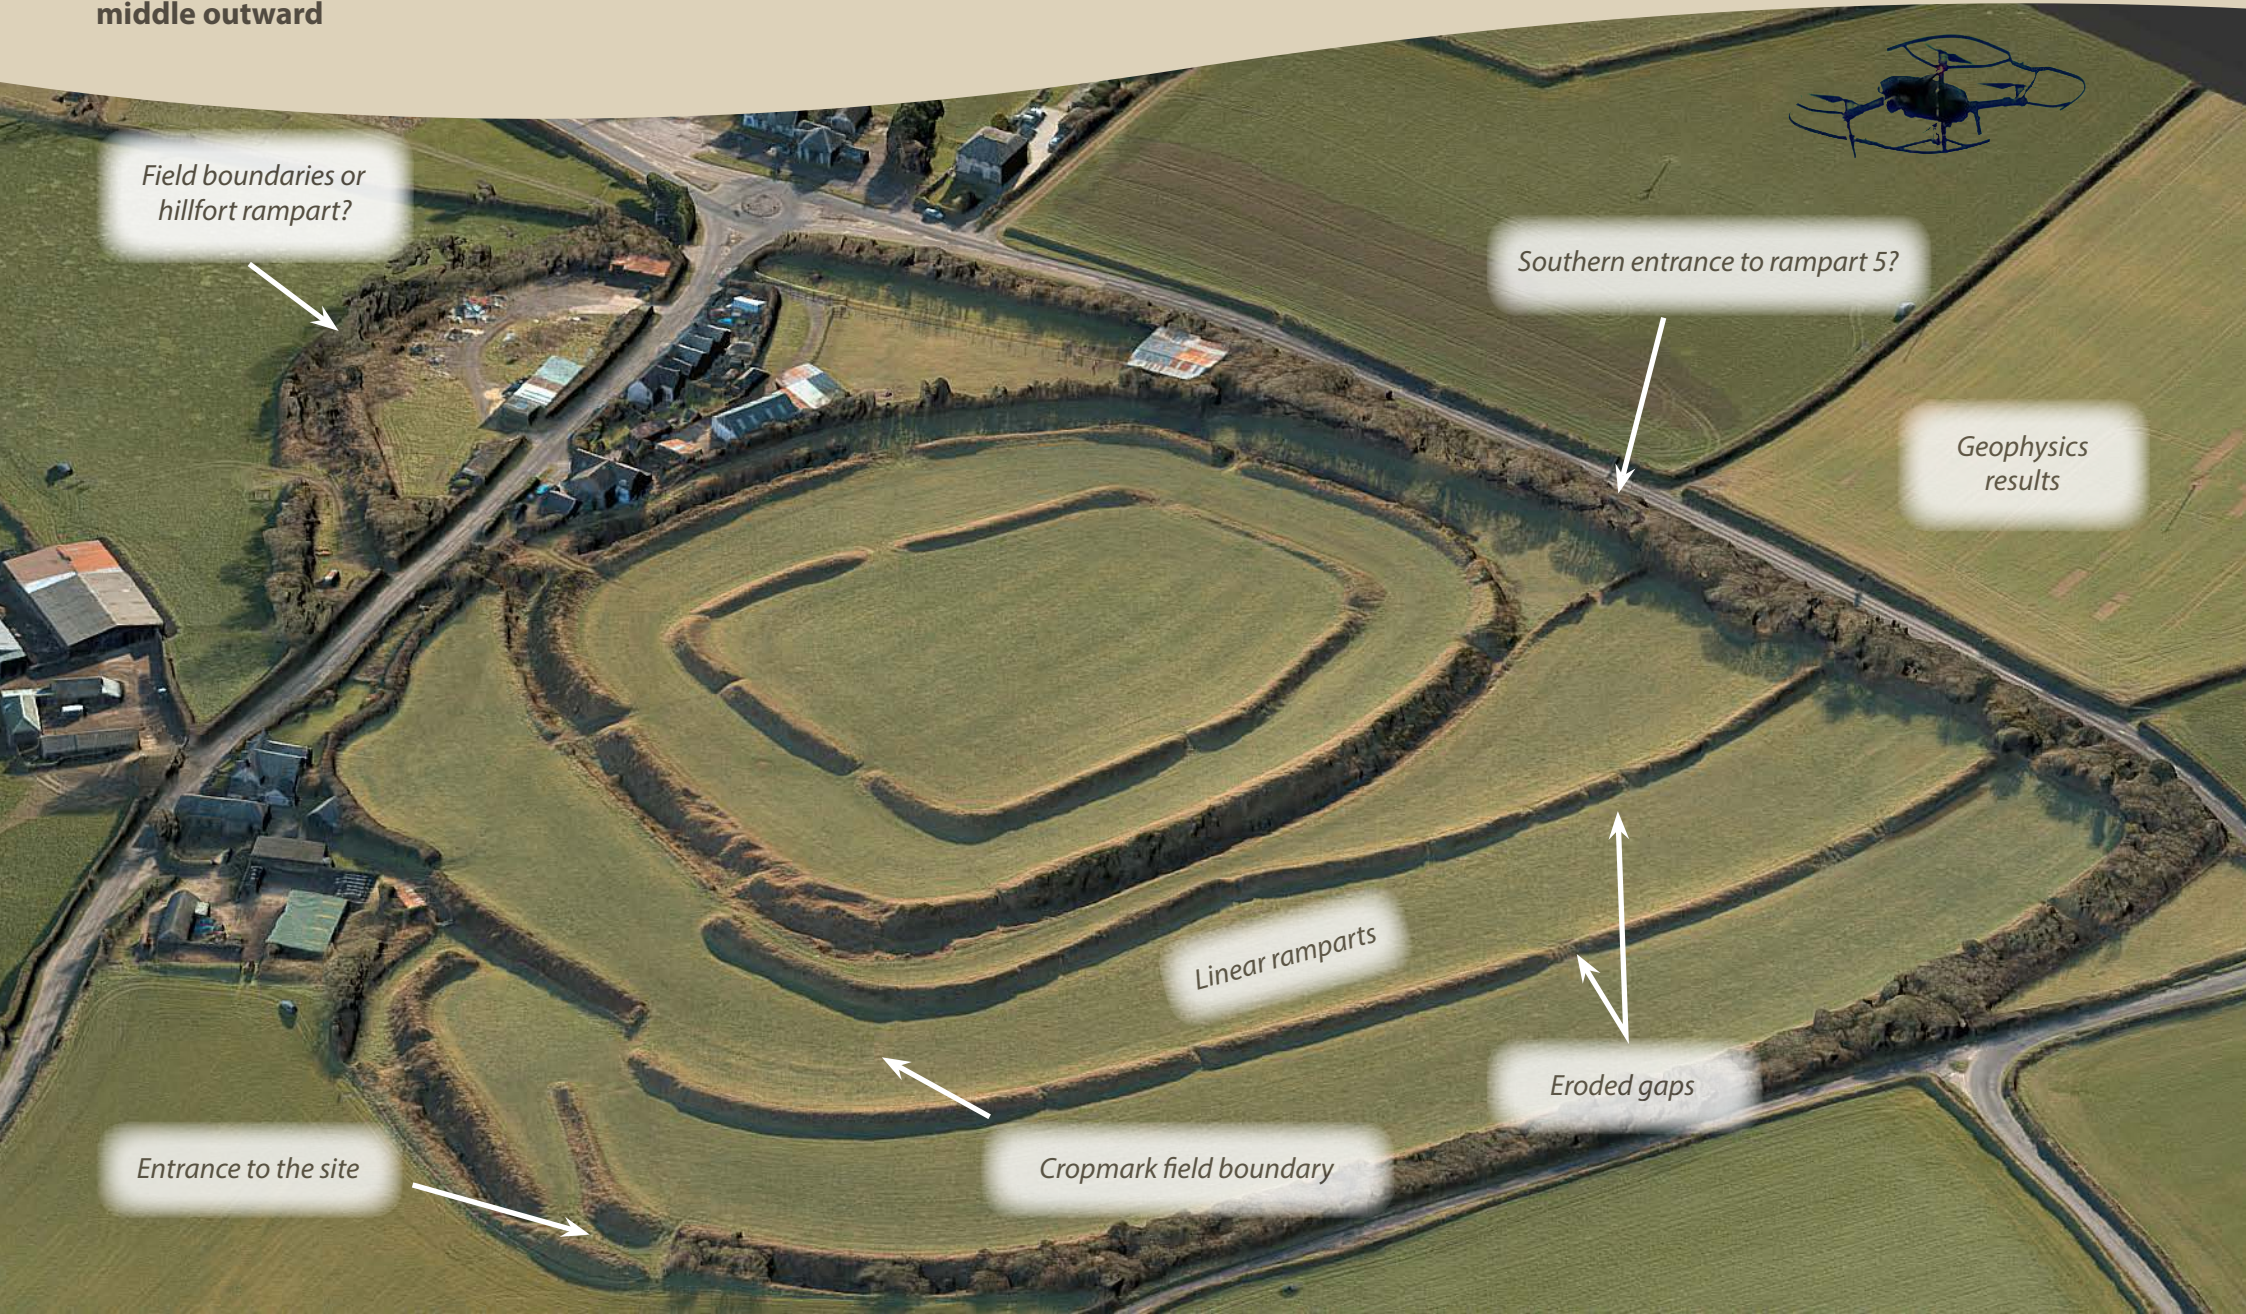
Ramparts (banks and ditches forming enclosed spaces) are numbered 1-5 from the middle outward

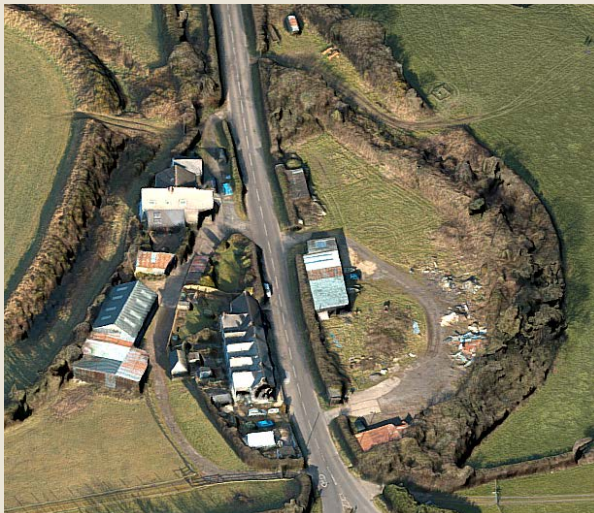
Field boundaries or hillfort rampart?

The linear banks on the east side of the B237 curve in a form which might suggest they are related to the hillfort. But are these banks part of the hillfort, or were they constructed in the medieval period or later, as field boundaries? Or perhaps they originated as part of the hillfort, and were later changed to be better for keeping livestock? This site raises many interesting questions.

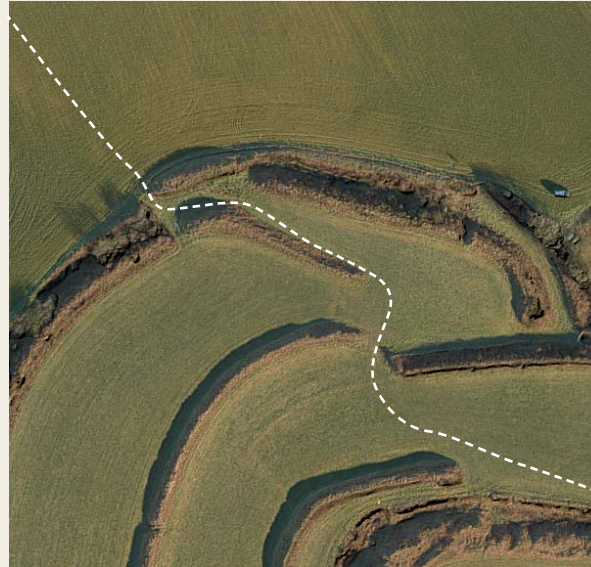
Entrance to the site

It is not unusual for hillforts to have a complex entrance route. There are some earthworks which show that there has been some effort made in the construction of the outer rampart to guide the route of entry through a narrow gap in the north-west, where there is a separate

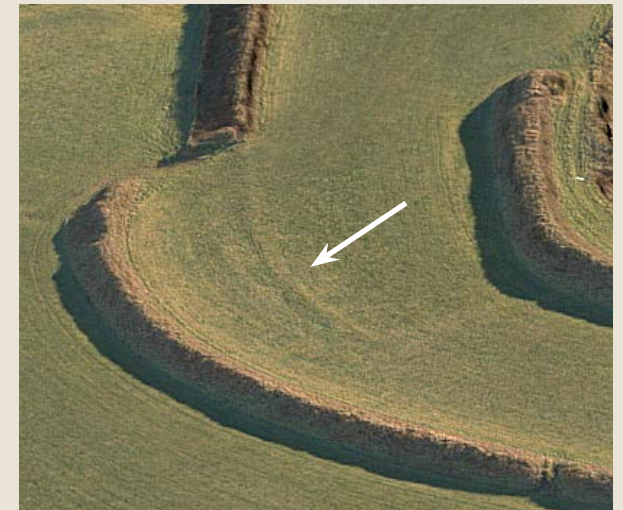
Cropmark field boundary

Historic maps show that the site has changed a little over the past 100 years or so. These changes included the addition and removal of some field boundaries, including one between ramparts 3 and 4. In the right conditions, the position of this field boundary can still be seen as a cropmark. This cropmark is seen on the ground where the buried remnants of the old boundary have changed how the grass on the surface grows compared to the area around it.

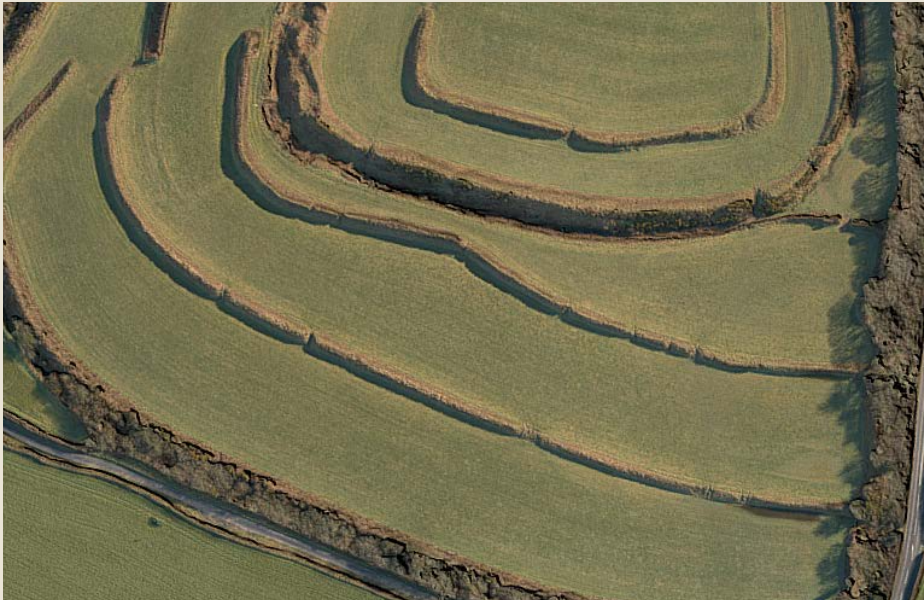
Linear ramparts

The layout of Clovelly Dykes hillfort isn't typical of this type of monument. Ramparts 3 and 4 do not enclose any land themselves, although they do divide the land on the downward slope on the west of the site. These may have been added to the site during a different phase of use to when ramparts 1, 2 and 5 were constructed, with a focus on containing livestock rather than marking the location of a settlement or defensive enclosure. Ramparts 3 and 4 are very different in character to the other ramparts – they do not appear to be ditched, and the banks are comparatively low, but are effective due to the natural slope here.

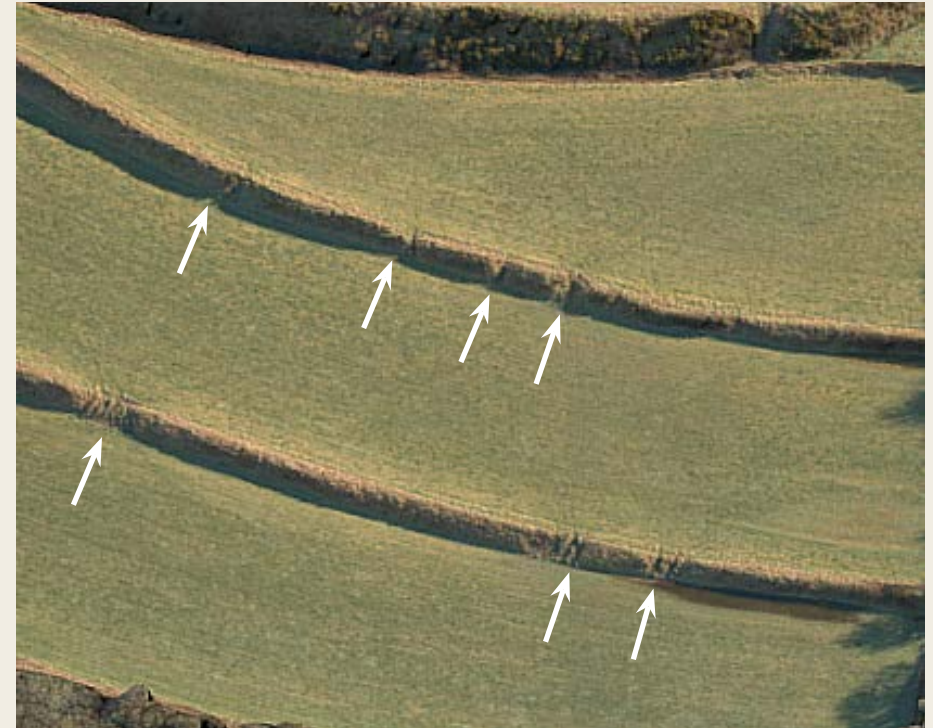
Eroded gaps

There are a number of gaps in the ramparts which are a result of the movement of people, animals, and vehicles across the site, such as these on ramparts 3 and 4. Over time, the routes across the ramparts have been worn away.

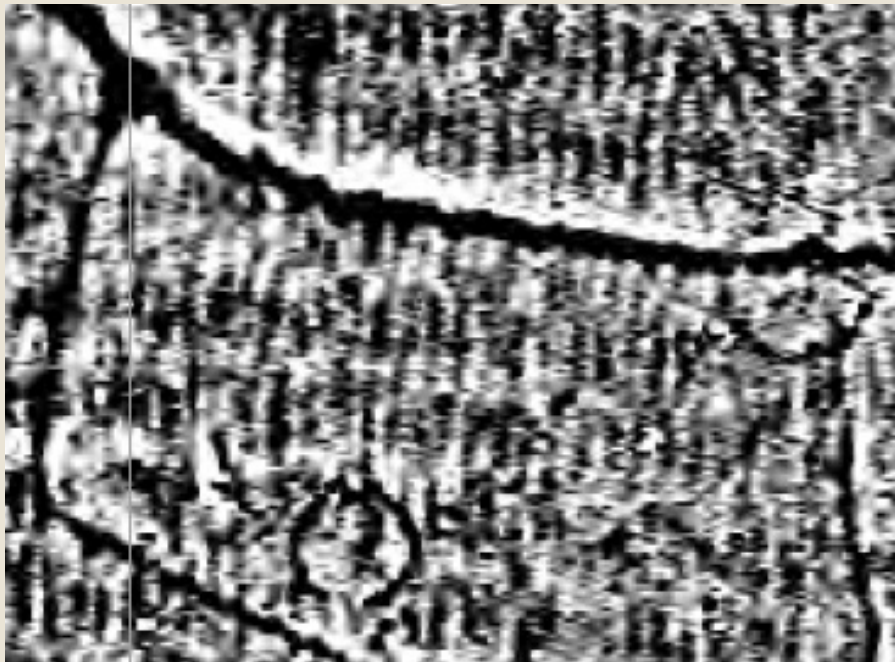
Geophysics results

Geophysics to the south of the hillfort has shown some possible buried features which could be related to the use of the hillfort. These features included a possible linear feature which could have been part of a rampart, and circular features which can sometimes show the location of a buried Iron Age house.

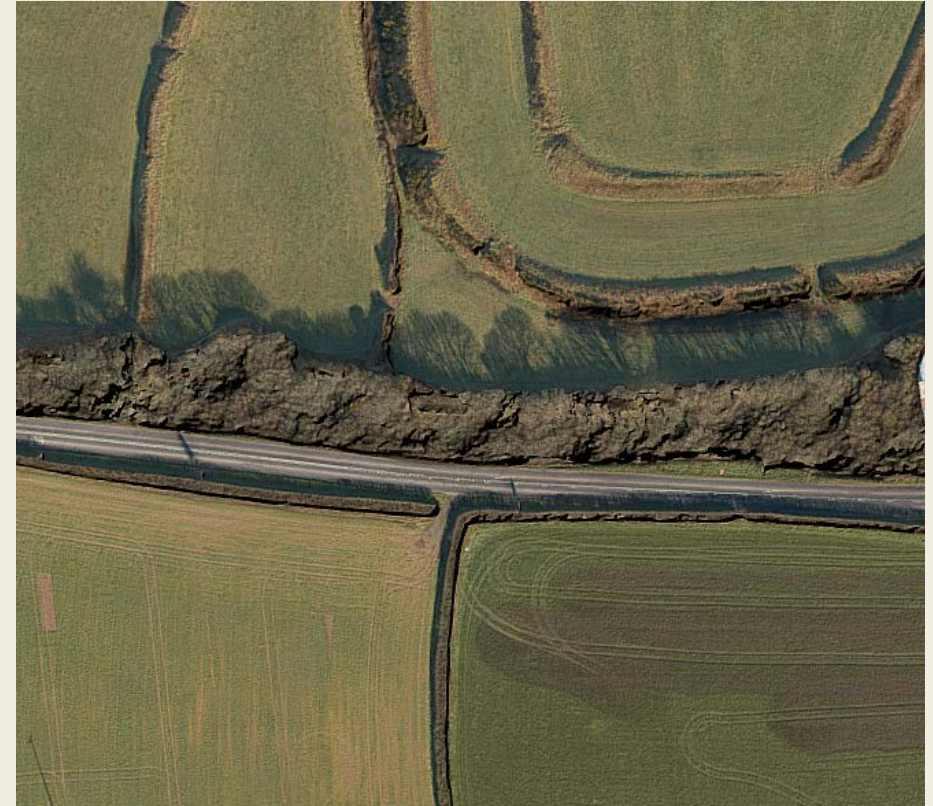
Southern entrance to rampart 5?

What is hidden beneath the trees in the south of the hillfort? Historic maps show that there may be an original entrance gap in the 5th rampart here, although this part of the site isn't currently accessible to see this entrance.
